Manhole Inspection Summary

Manhole # S31CC_026MH

Location Address: **EUTAW ST**

Cross Street: **PRESTON ST**

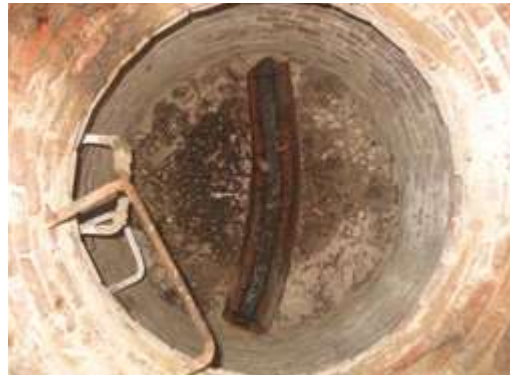
Top View

Corroded steps. Bench debris.

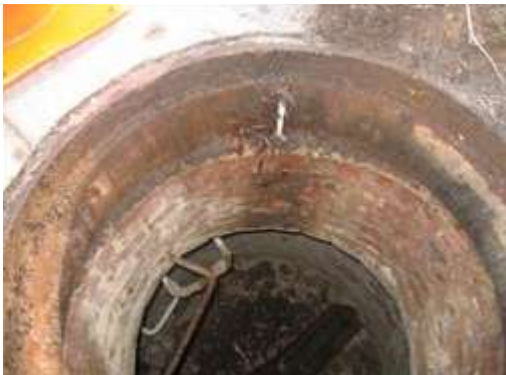
Defect

Frame Offset: **0** (in.) Condition: ☐ Sound ☐ Cracked ☒ **Leaks**

Infiltration: ☐ None ☒ **Joint** ☐ Cracks ☒ **Mortar** ☐ Roots ☐ Wall

Infiltration: ☐ None ☐ Joint ☐ Cracks ☒ **Mortar** ☐ Roots ☒ **Wall**

Frame leaks. Frame offset. Adjustment and Barrel infiltration.

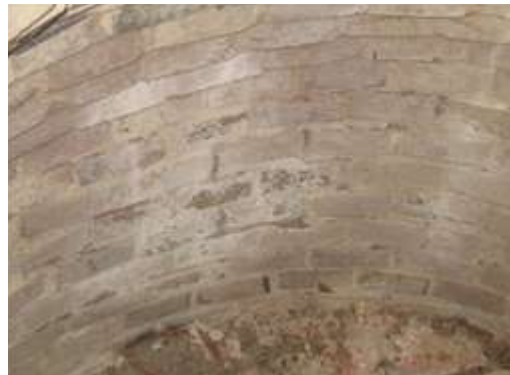
Defect

Barrel infiltration.

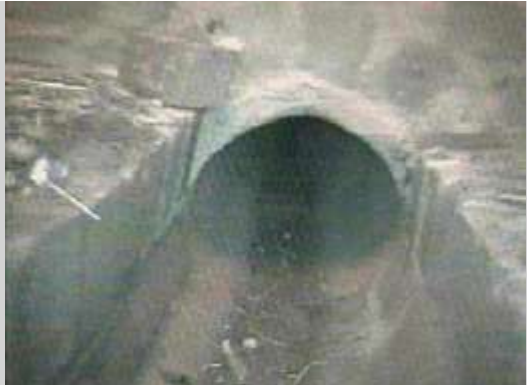
8 in. Circular Gravity Sewer Pipe Out @ 12 O'Clock

Deposits: ☐ None ☒ **Mud** ☐ Sludge ☒ **Debris** ☐ Grease

Silt Depth: **0** (in.) Deposits Extent: **Light**
